FABRIC DEFECTS

CASE HISTORIES OF IMPERFECTIONS
IN WOVEN COTTON AND RAYON FABRICS

J. B. GOLDBERG

Fellow of the Textile Institute
Research Director, J. P. Stevens & Co., Inc.

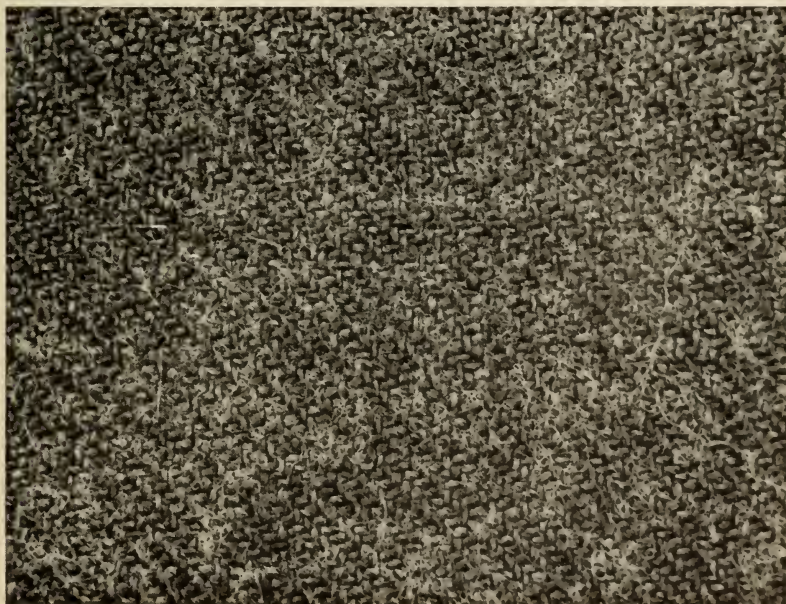
FIG. 82b. Defective—piece not fulled.

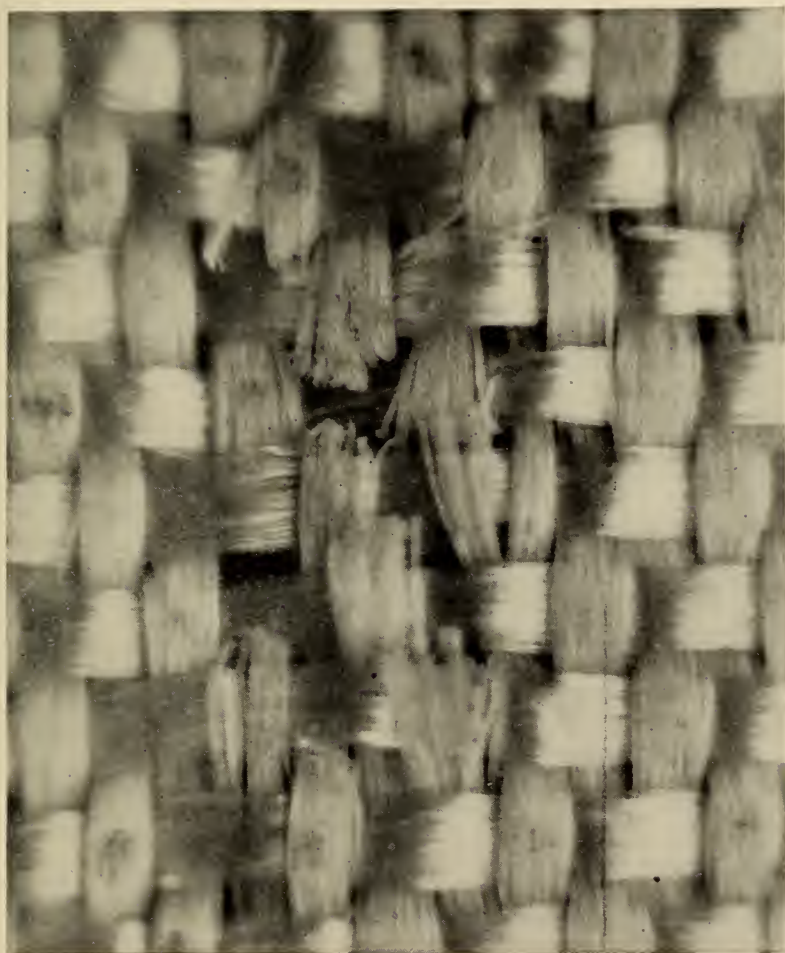
FIG. 83. Insect damage to warp yarns.

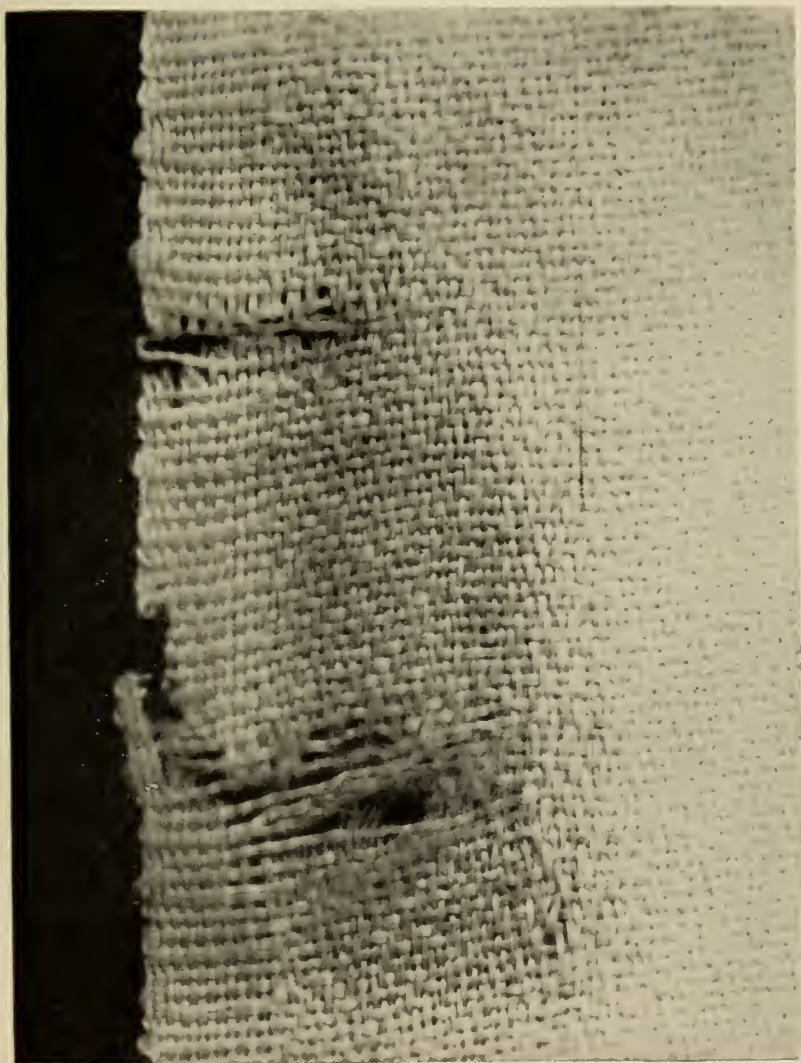
FIG. 84. Deterioration by acid.

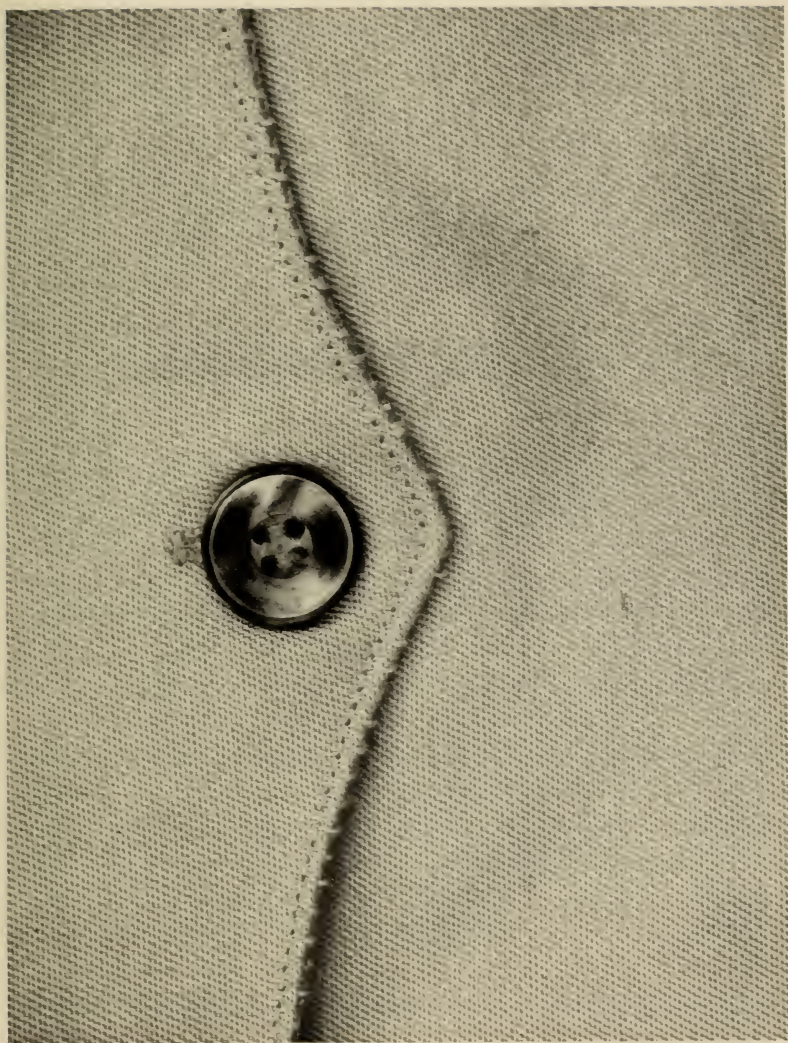
FIG. 88. Frayed appearance due to needle cutting.

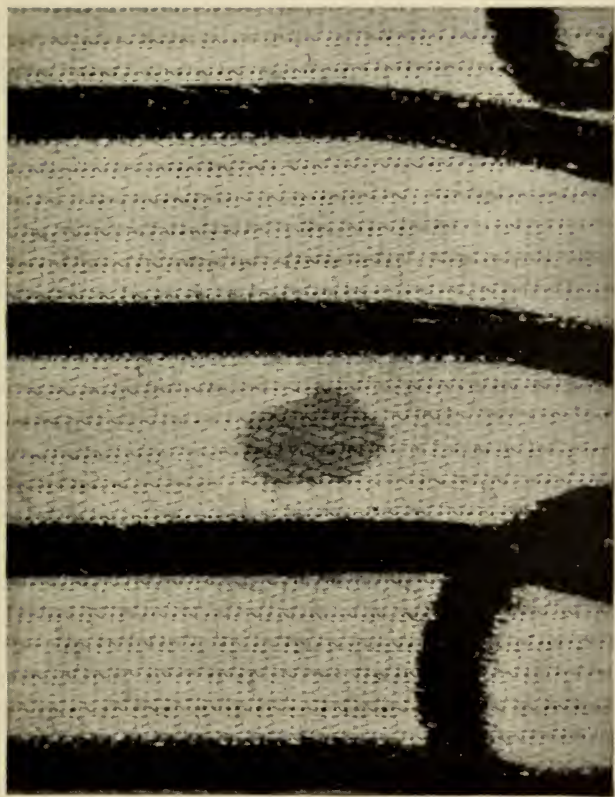
FIG. 89. Paint stain on white portion of printed fabric.

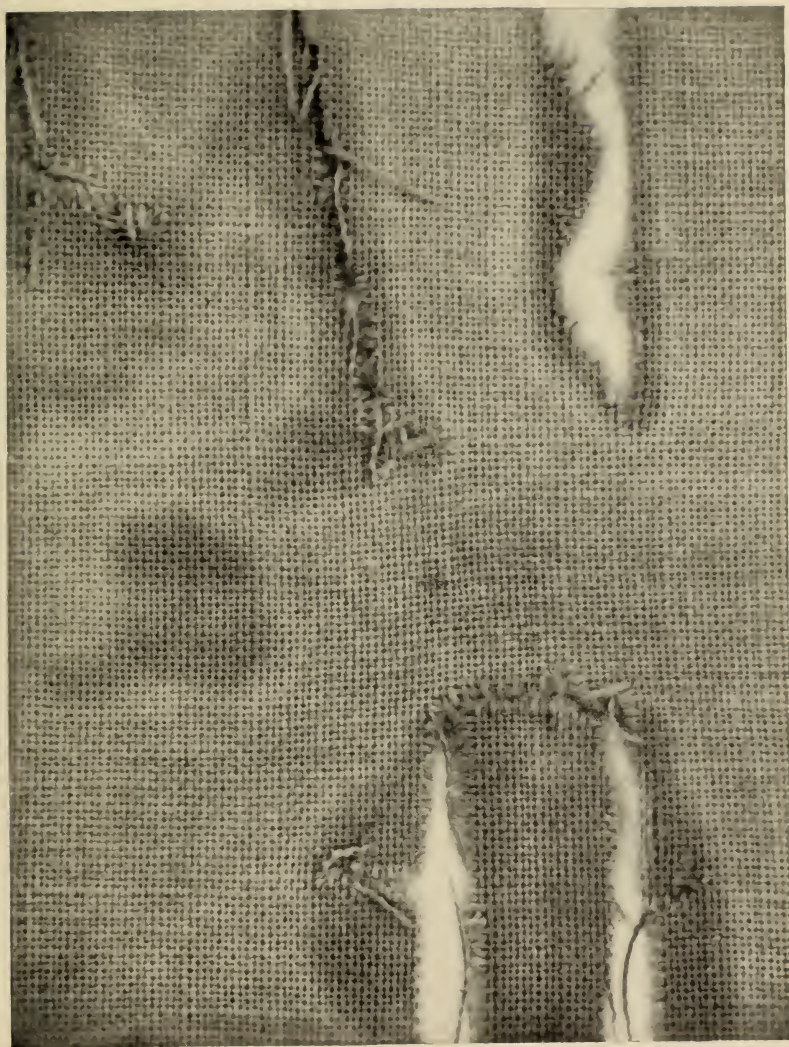
FIG. 90. Tender areas probably due to overbleaching by the finisher. (Dark stains are from methylene blue reagent used to detect presence of oxycellulose.)

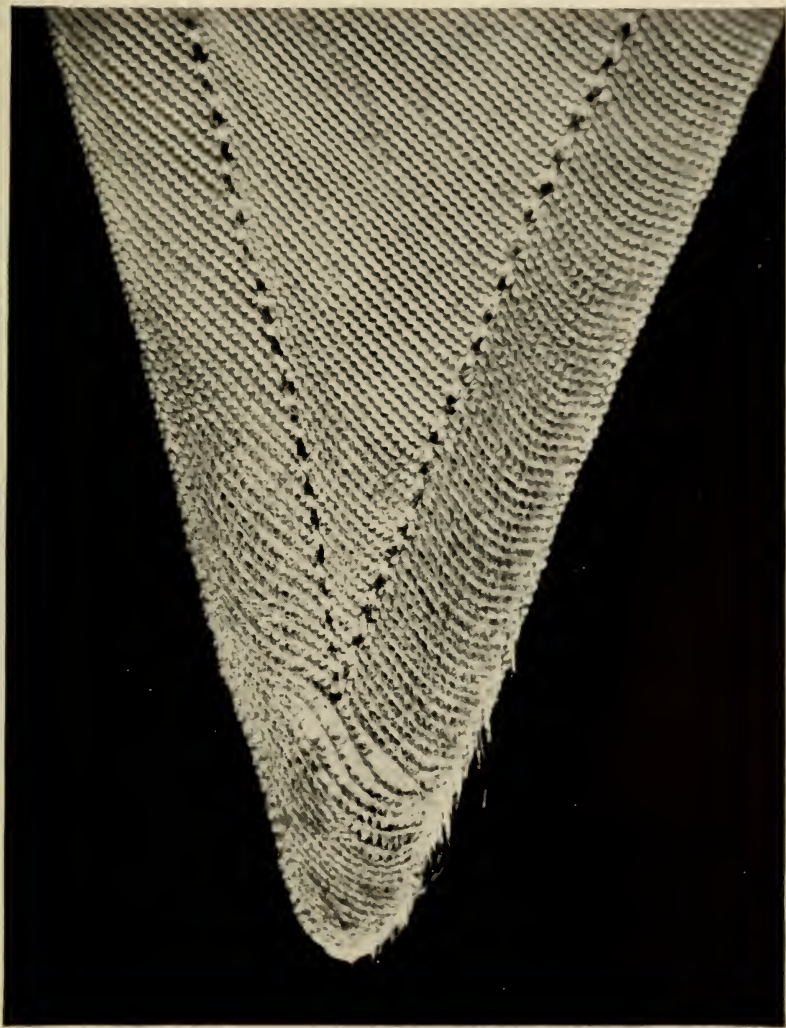
FIG. 92. Damage due to melting of acetate rayon by use of too hot an iron.
